Home Report

Scottish
Single Survey

Property address	43 Broompark Drive Glasgow G31 2JB
Customer	Church of Scotland
Customer address	43 Broompark Drive Glasgow G31 2JB
Prepared by	Shepherd Chartered Surveyors
Date of inspection	25/07/2024

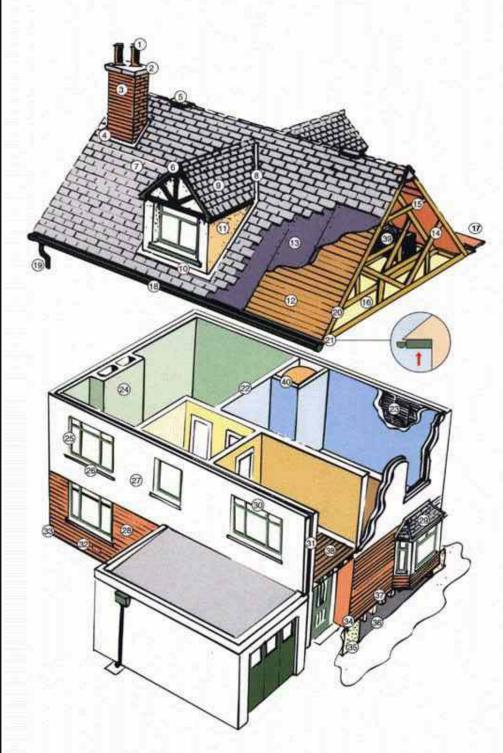
Sectional Diagram showing elements of a typical house

Reference may be made in this report to some or all of the above component parts of the property. This diagram may assist you in locating and understanding these items.

- 1) Chimney pots
- 2) Coping stone
- 3) Chimney head
- (4) Flashing
- 5) Ridge ventilation
- (6) Ridge board
- (7) Slates / tiles
- 8 Valley guttering
- 9 Dormer projection
- 10) Dormer flashing
- 11) Dormer cheeks
- (12) Sarking
- 13) Roof felt
- (14) Trusses
- (15) Collar
- 16) Insulation
- (17) Parapet gutter
- 18) Eaves guttering
- (19) Rainwater downpipe
- 20) Verge boards/skews
- Soffit boards
- 22) Partition wall
- 23) Lath / plaster
- (24) Chimney breast
- 25) Window pointing
- 26) Window sills
- 27) Rendering
- (28) Brickwork / pointing
- 29 Bay window projection
- (30) Lintels
- (31) Cavity walls / wall ties
- 32) Subfloor ventilator
- (33) Damp proof course
- 34) Base course
- (35) Foundations
- 36) Solum
- 37) Floor joists
- 38) Floorboards
- 9) Water tank
- 40) Hot water tank
