Home Report

Single Survey

Property address	43 Lanark Road West Currie EH14 5JX
Customer	Church of Scotland
Customer address	43 Lanark Road West Currie EH14 5JX
Prepared by	Shepherd Chartered Surveyors
Date of inspection	23/09/2024

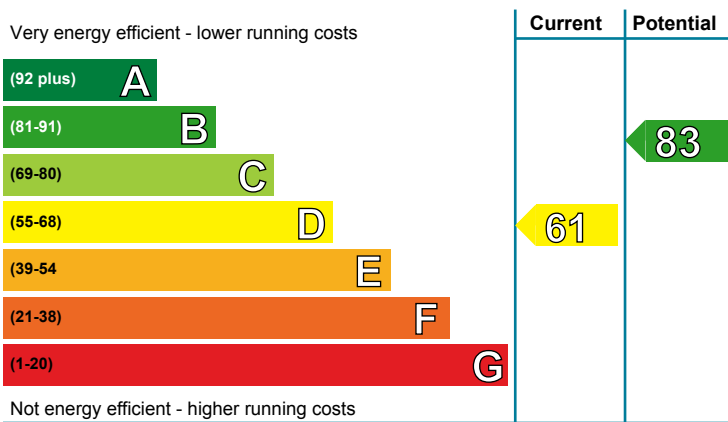
Energy Efficiency Rating

This graph shows the current efficiency of your home, taking into account both energy efficiency and fuel costs. The higher this rating, the lower your fuel bills are likely to be.

Your current rating is **band D (61)**. The average rating for EPCs in Scotland is **band D (61)**.

The potential rating shows the effect of undertaking all of the improvement measures listed within your recommendations report.

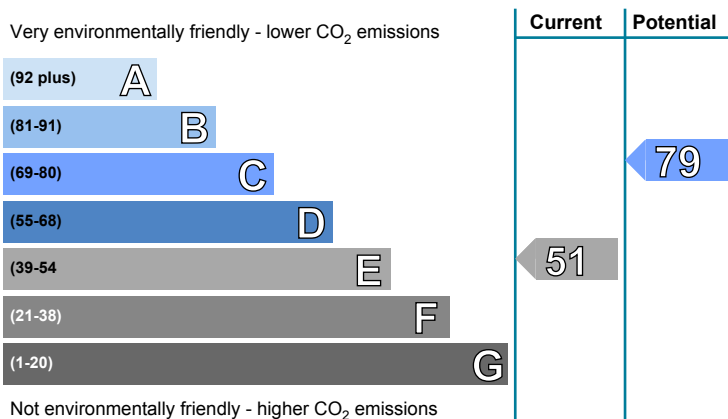
Environmental Impact (CO₂) Rating

This graph shows the effect of your home on the environment in terms of carbon dioxide (CO₂) emissions. The higher the rating, the less impact it has on the environment.
