Home Report

1. Scottish Single Survey
 2. Energy Performance Certificate
 3. Property Questionnaire
-

Single Survey

Property address	5 Westwater Place Wormit Newport-on-Tay DD6 8NS
Customer	Church of Scoland
Customer address	5 Westwater Place Wormit Newport-on-Tay DD6 8NS
Prepared by	Shepherd Chartered Surveyors
Date of inspection	18/06/2024

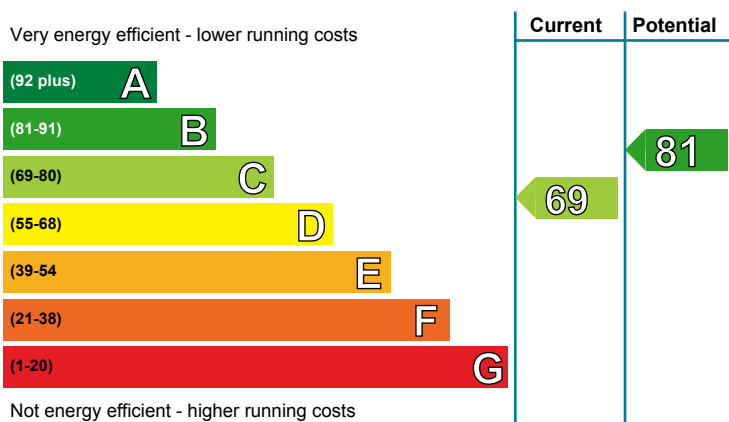
Energy Efficiency Rating

This graph shows the current efficiency of your home, taking into account both energy efficiency and fuel costs. The higher this rating, the lower your fuel bills are likely to be.

Your current rating is **band C (69)**. The average rating for EPCs in Scotland is **band D (61)**.

The potential rating shows the effect of undertaking all of the improvement measures listed within your recommendations report.

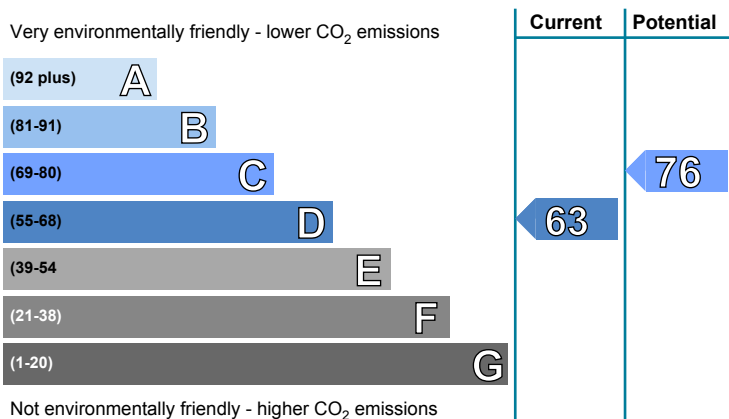
Environmental Impact (CO₂) Rating

This graph shows the effect of your home on the environment in terms of carbon dioxide (CO₂) emissions. The higher the rating, the less impact it has on the environment.
