Home Report

Scottish Single Survey

Single Survey

Property address	Arbirlot Manse Arbirlot Arbroath DD11 2NX
Customer	Church of Scotland
Customer address	Arbirlot Manse Arbirlot Arbroath DD11 2NX
Prepared by	Shepherd Chartered Surveyors
Date of inspection	27/11/2024

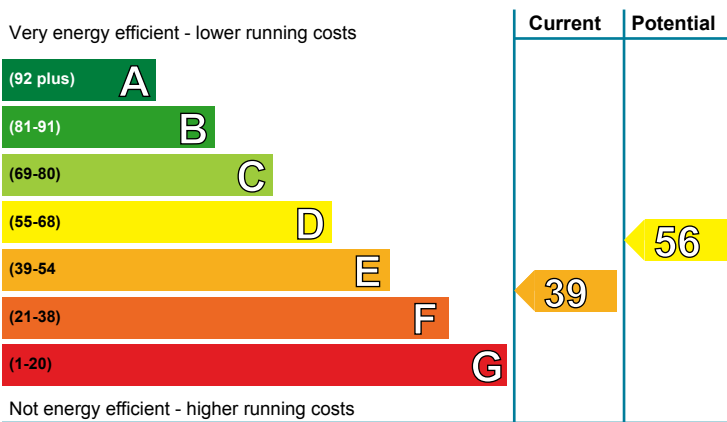
Energy Efficiency Rating

This graph shows the current efficiency of your home, taking into account both energy efficiency and fuel costs. The higher this rating, the lower your fuel bills are likely to be.

Your current rating is **band E (39)**. The average rating for EPCs in Scotland is **band D (61)**.

The potential rating shows the effect of undertaking all of the improvement measures listed within your recommendations report.
