# Home Report

# Scottish Single Survey

Property address	Creebridge Manse Minnigaff Newton Stewart  DG8 6NR
Customer	Church of Scotland
Customer address	Creebridge Manse Minnigaff Newton Stewart  DG8 6NR
Prepared by	Shepherd Chartered Surveyors
Date of increasion	06/05/2024
Date of inspection	06/05/2024

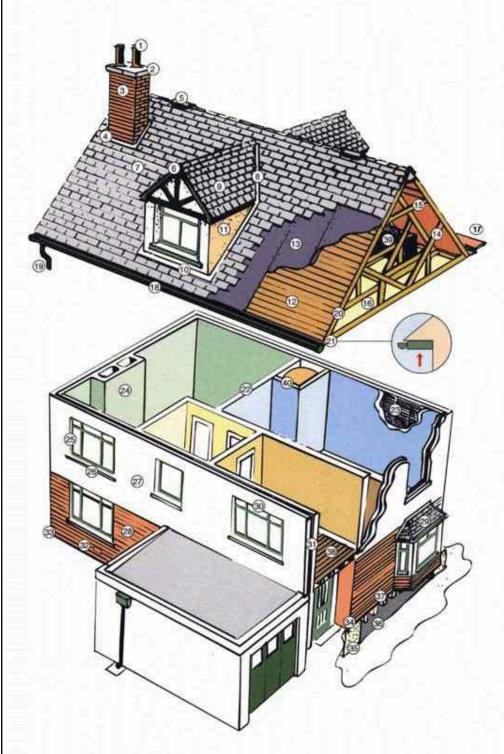
### Sectional Diagram showing elements of a typical house

Reference may be made in this report to some or all of the above component parts of the property. This diagram may assist you in locating and understanding these items.

- 1) Chimney pots
- 2) Coping stone
- 3) Chimney head
- (4) Flashing
- 5) Ridge ventilation
- 6) Ridge board
- (7) Slates / tiles
- 8 Valley guttering
- 9 Dormer projection
- 10 Dormer flashing
- 11) Dormer cheeks
- (12) Sarking
- 13) Roof felt
- (14) Trusses
- (15) Collar
- 16) Insulation
- (17) Parapet gutter
- 18) Eaves guttering
- (19) Rainwater downpipe
- 20) Verge boards/skews
- 21) Soffit boards
- 22) Partition wall
- (23) Lath / plaster
- (24) Chimney breast
- 25) Window pointing
- 26) Window sills
- 27) Rendering
- 28) Brickwork / pointing
- 29 Bay window projection
- (30) Lintels
- (31) Cavity walls / wall ties
- 32) Subfloor ventilator
- (33) Damp proof course
- 34) Base course
- 35) Foundations
- 36) Solum
- 7) Floor joists
- 38) Floorboards
- 9) Water tank
- (40) Hot water tank
