Home Report

Scottish Single Survey

Property address	110 Main Street Alford AB33 8AD
Customer	Church of Scotland
Customer address	110 Main Street Alford AB33 8AD
Prepared by	Shepherd Chartered Surveyors
Date of inspection	21/11/2024

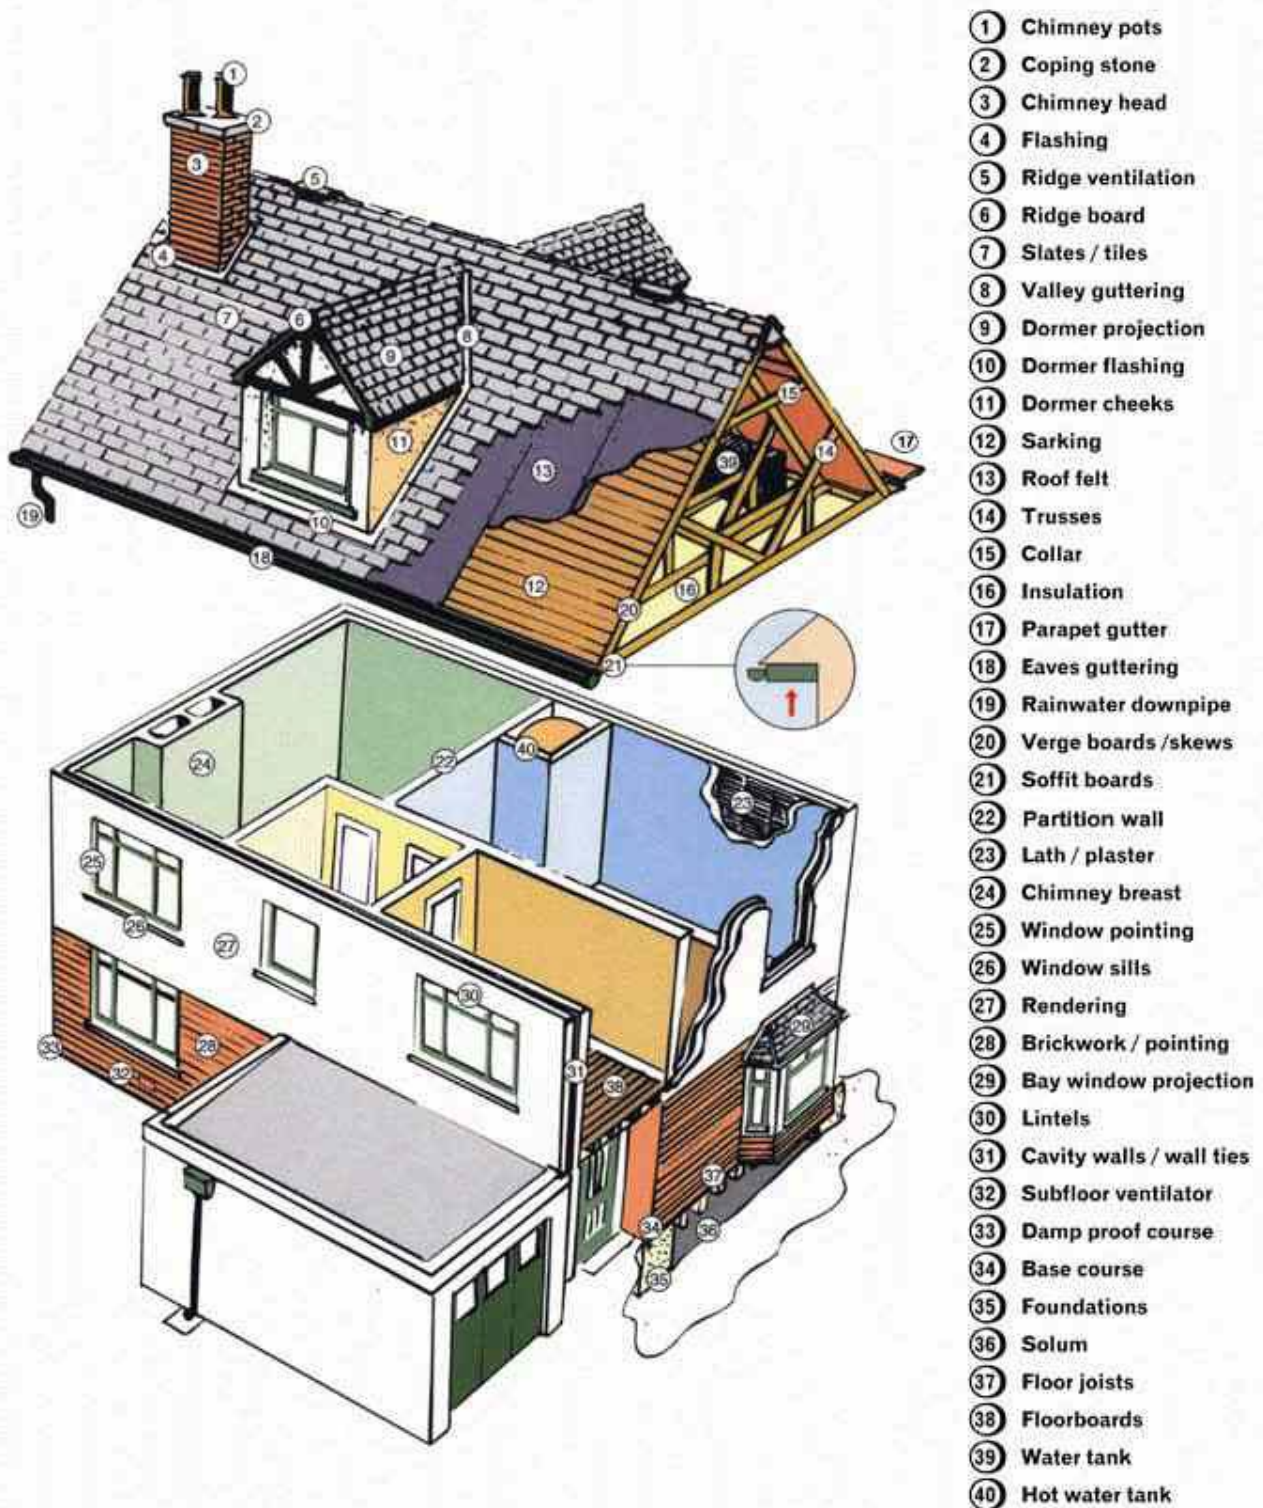
Sectional Diagram showing elements of a typical house

Reference may be made in this report to some or all of the above component parts of the property. This diagram may assist you in locating and understanding these items.

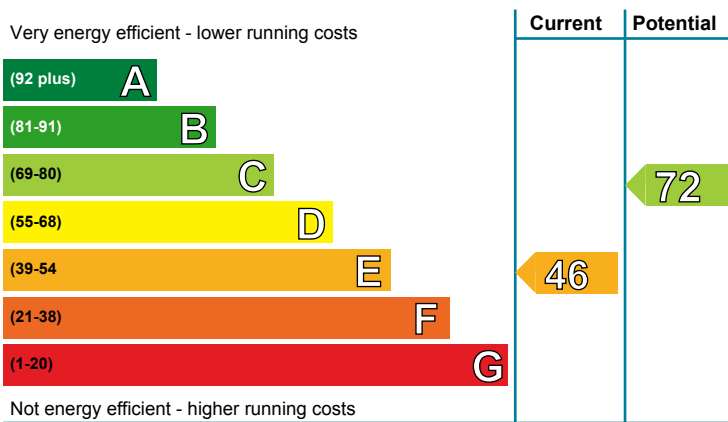
Energy Efficiency Rating

This graph shows the current efficiency of your home, taking into account both energy efficiency and fuel costs. The higher this rating, the lower your fuel bills are likely to be.

Your current rating is **band E (46)**. The average rating for EPCs in Scotland is **band D (61)**.

The potential rating shows the effect of undertaking all of the improvement measures listed within your recommendations report.

Estimated energy costs for your home for 3 years*	£12,873	See your recommendations report for more information
Over 3 years you could save*	£4,872

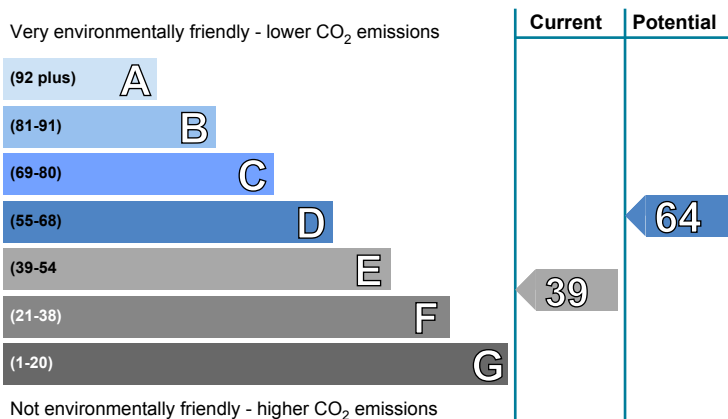
Environmental Impact (CO₂) Rating

This graph shows the effect of your home on the environment in terms of carbon dioxide (CO₂) emissions. The higher the rating, the less impact it has on the environment.
