# **Home Report**

Scottish
Single Survey

# survey report on:

Property address	8 Mossbank Drive Glasgow G33 1LS
Customer	Church of Scotland
Customer address	8 Mossbank Drive Glasgow G33 1LS
Prepared by	Shepherd Chartered Surveyors
Date of inspection	13/02/2025

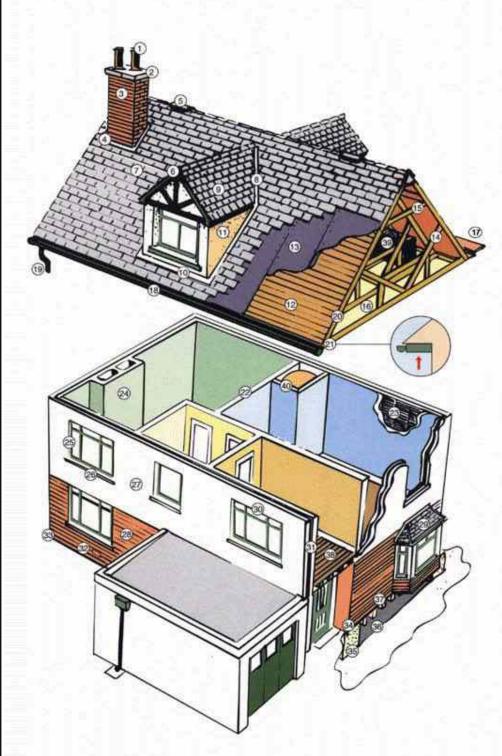
### Sectional Diagram showing elements of a typical house

Reference may be made in this report to some or all of the above component parts of the property. This diagram may assist you in locating and understanding these items.

- 1) Chimney pots
- 2) Coping stone
- 3) Chimney head
- (4) Flashing
- 5) Ridge ventilation
- 6 Ridge board
- 7 Slates / tiles
- 8 Valley guttering
- 9 Dormer projection
- 10 Dormer flashing
- 11 Dormer cheeks
- (12) Sarking
- (13) Roof felt
- 14) Trusses
- 15) Collar
- 16) Insulation
- 17) Parapet gutter
- 18) Eaves guttering
- (19) Rainwater downpipe
- 20) Verge boards /skews
- 21) Soffit boards
- 22) Partition wall
- 23) Lath / plaster
- (24) Chimney breast
- 25) Window pointing
- 26) Window sills
- 27) Rendering
- 28) Brickwork / pointing
  - 29) Bay window projection
- (30) Lintels
- (31) Cavity walls / wall ties
- 32) Subfloor ventilator
- (33) Damp proof course
- 34) Base course
- (35) Foundations
- 36) Solum
- 37) Floor joists
- 38) Floorboards
- 39) Water tank
- 40) Hot water tank
