Home Report

Single Survey

Property address	3 Carlisle Road Hamilton ML3 7BZ
Customer	Church of Scotland
Customer address	3 Carlisle Road Hamilton ML3 7BZ
Prepared by	Shepherd Chartered Surveyors
Date of inspection	30/05/2024

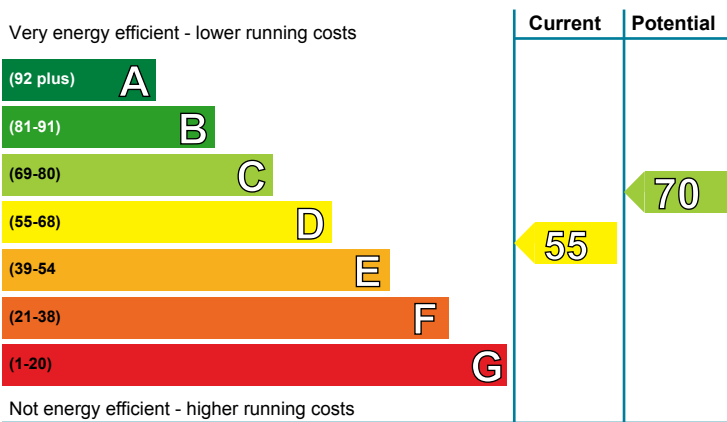
Energy Efficiency Rating

This graph shows the current efficiency of your home, taking into account both energy efficiency and fuel costs. The higher this rating, the lower your fuel bills are likely to be.

Your current rating is **band D (55)**. The average rating for EPCs in Scotland is **band D (61)**.

The potential rating shows the effect of undertaking all of the improvement measures listed within your recommendations report.
