# HOME REPORT

THE MANSE PENCAITLAND

TRANENT  
EH34 5DL

# Energy Performance Certificate (EPC)

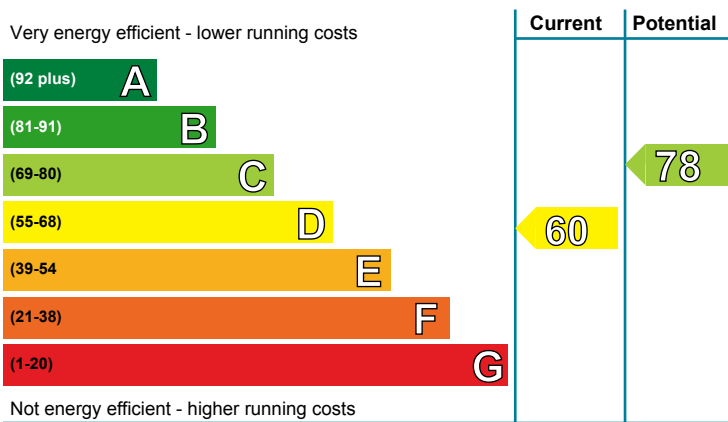
## Energy Efficiency Rating

This graph shows the current efficiency of your home, taking into account both energy efficiency and fuel costs. The higher this rating, the lower your fuel bills are likely to be.

Your current rating is **band D (60)**. The average rating for EPCs in Scotland is **band D (61)**.

The potential rating shows the effect of undertaking all of the improvement measures listed within your recommendations report.

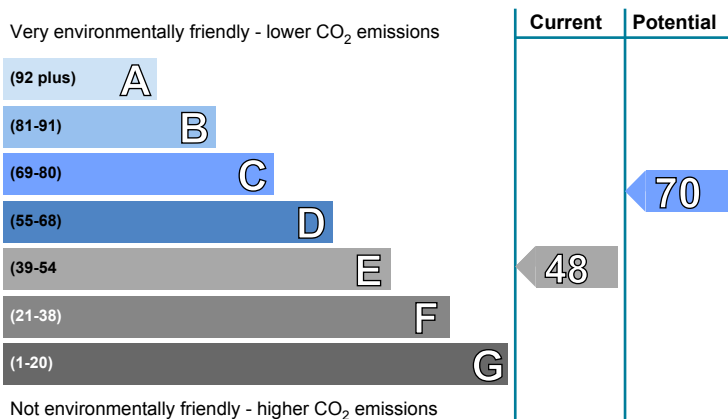
## Environmental Impact (CO<sub>2</sub>) Rating

This graph shows the effect of your home on the environment in terms of carbon dioxide (CO<sub>2</sub>) emissions. The higher the rating, the less impact it has on the environment.

Your current rating is **band E (48)**. The average rating for EPCs in Scotland is **band D (59)**.

The potential rating shows the effect of undertaking all of the improvement measures listed within your recommendations report.
